# **The Performance of Low-Rise Open Span Heavy Steel Structures In Extreme Winds**

**A REPORT**

**CIVIL ENGINEERING**

**June, 1997**

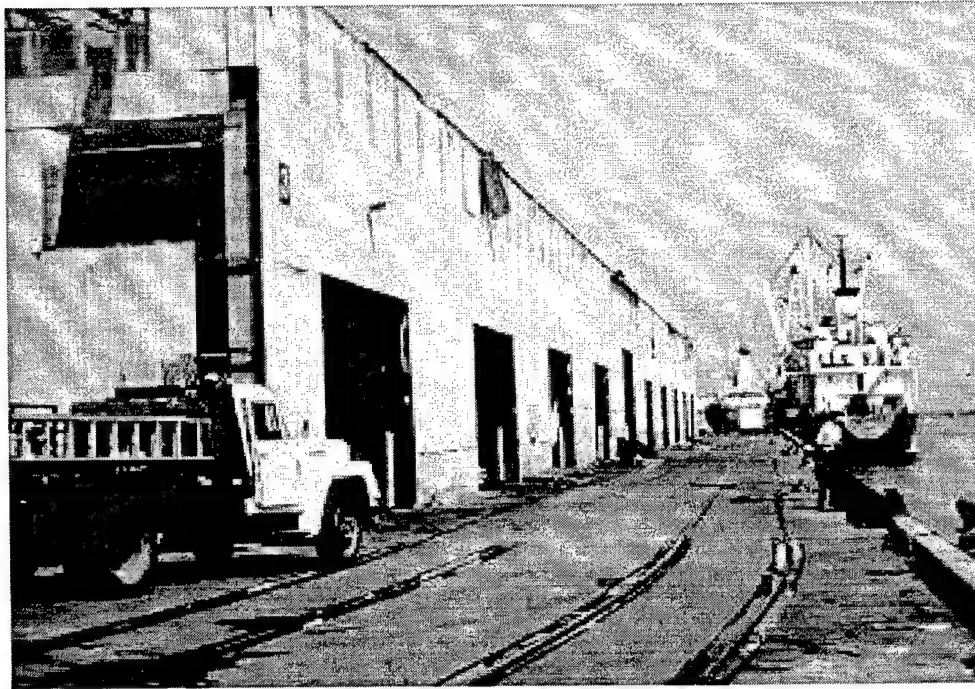
This warehouse building sustained no significant structural damage, as can be seen in Figures 4.1, 4.2, and 4.3. The only damage noted was the failure of several large overhead doors and the removal of some of the corrugated metal roof and wall panels.

The probable cause of the roof and wall panel failure was the prior failure of the large overhead doors located on the side of the building running parallel to the railroad tracks, as seen in Figure 4.1. These overhead doors failed due to positive pressure

generated by wind blowing normal to the surface of the doors. Once the two overhead doors failed, the internal pressure inside the building increased and the roof panels and siding were torn from the structure due to the combined internal and external pressure.

Figure 4.1 South Exterior Elevation of Building 3

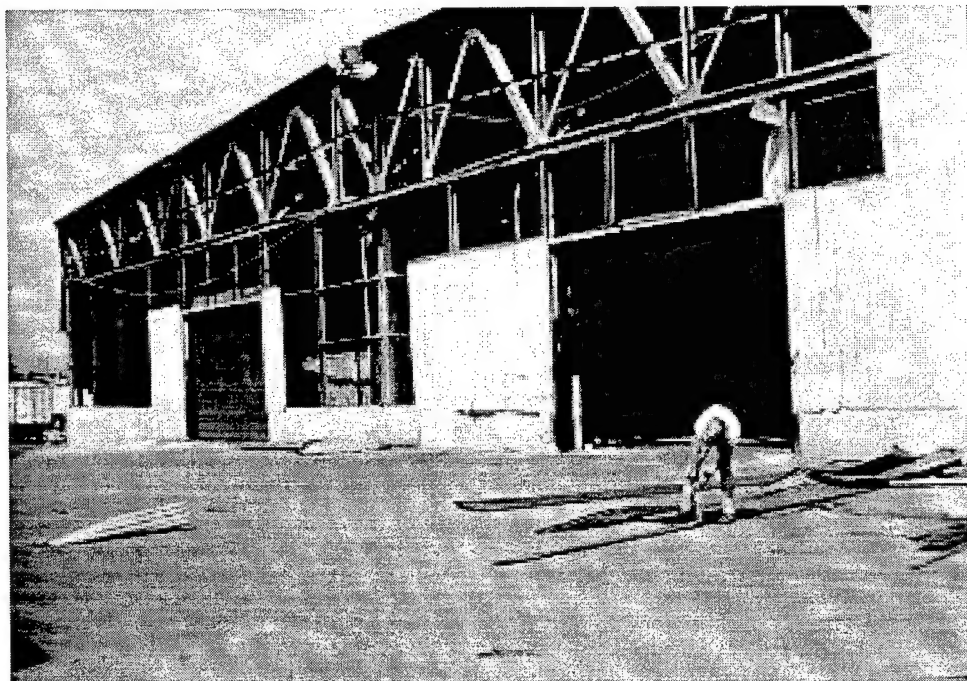
Figure 4.2 West Exterior Elevation of Building 3

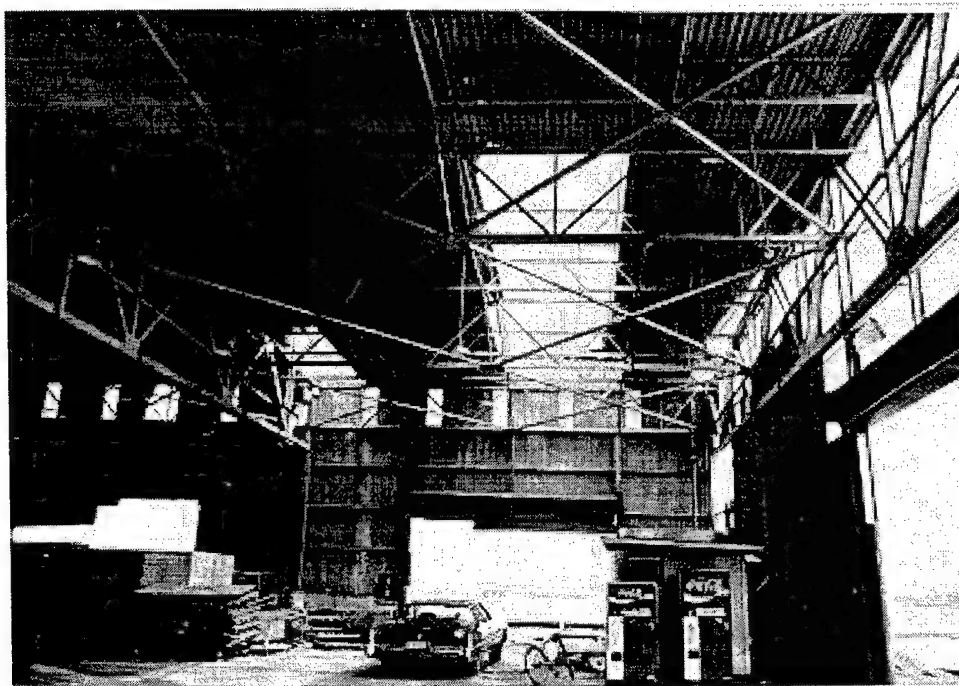
Figure 4.3 Interior Elevation of Building 3

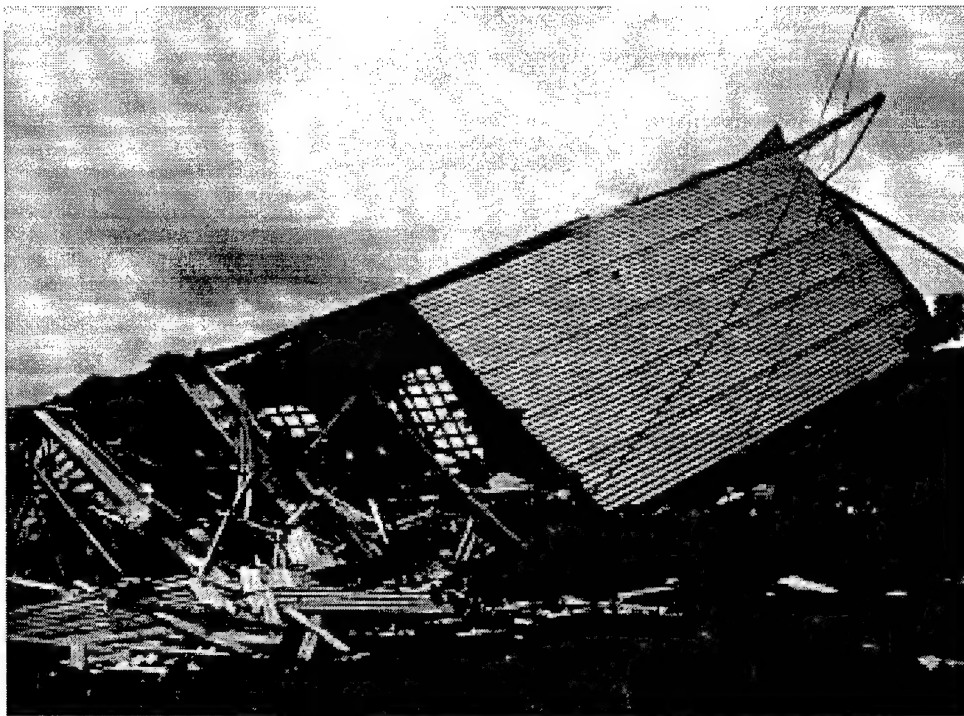
As seen in Figure 4.8, the parachute drying tower was totally destroyed by the Altus tornado. The failure of the tower was caused by excessive wind loads on the windward and leeward walls. These wind loads were sufficient to cause the anchor bolts on the southeast and northeast columns to fail in tension. Once the anchor bolts failed, the overturning moment generated by the easterly wind caused the building to rotate about the other two columns and collapse. A close up of the anchor bolt failure can be seen in Figure 4.9 and a close up of the column base plate in Figure 4.10. Figure 4.10 shows definitively that the base plate did not fail.

Figure 4.8 Failure of Parachute Tower

Using this approach, the overturning moment,  $M_o$ , was found to be 45.9q ft\*kips, where  $q$  is the wind pressure on the structure. Equating the righting moment,  $M_r$ , and the overturning moment,  $M_o$ , and solving for  $q$ , the wind pressure was determined to be approximately 48.0 psf. The minimum wind velocity to cause failure is then calculated using the equation,  $V = \sqrt{q/.00256}$ . Using this equation the minimum failure wind velocity was found to be 136 mph.

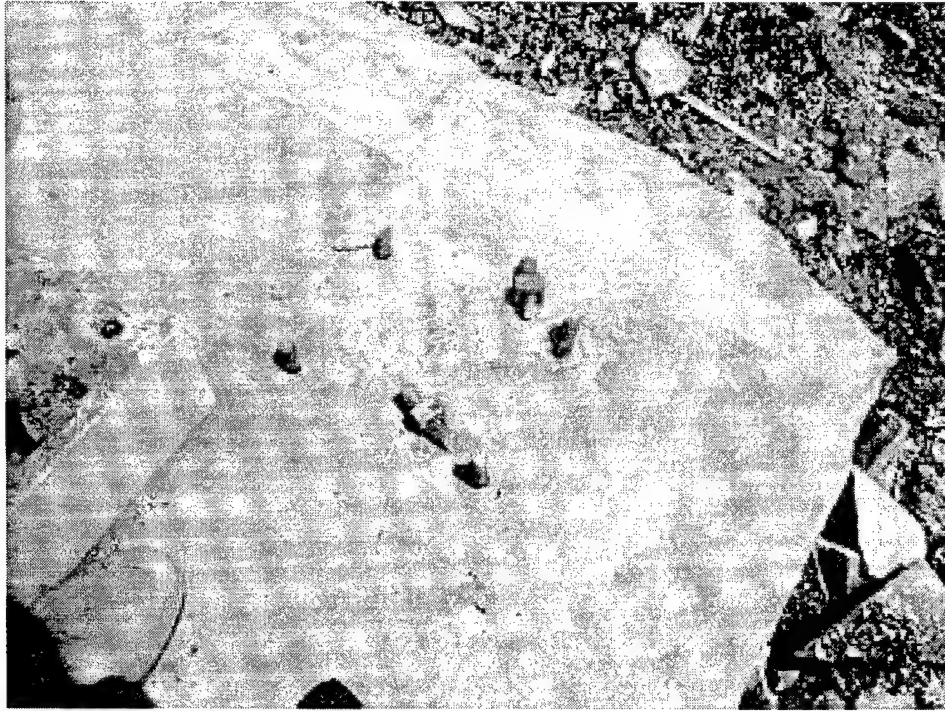
Figure 4.9 Anchor Bolt Failure, Parachute Tower

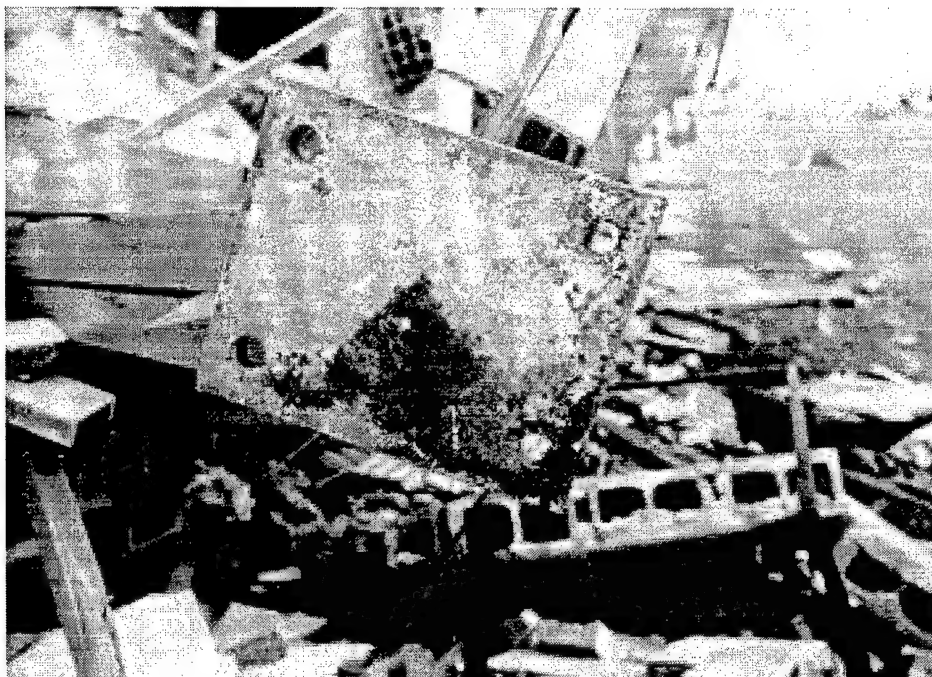
Figure 4.10 Column Base Plate, Parachute Tower

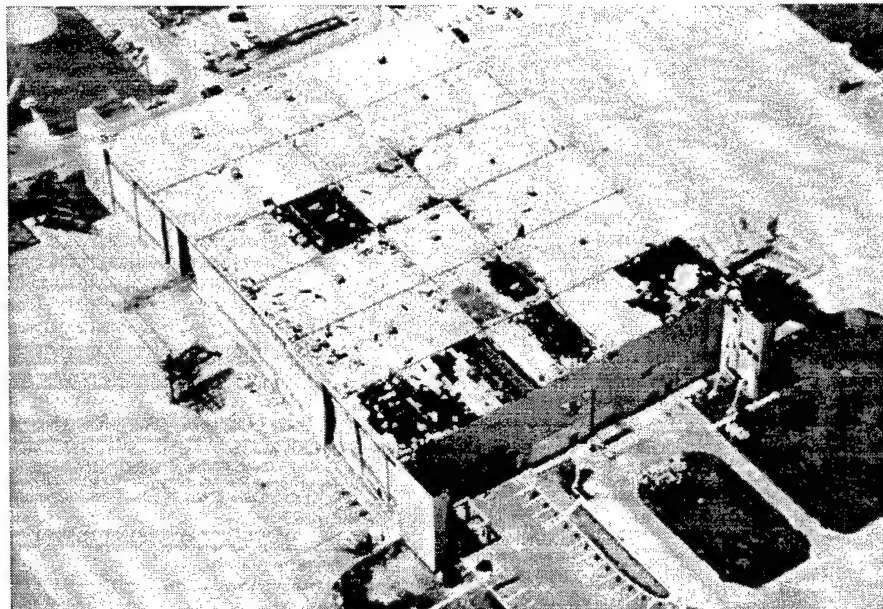
Overall, the hangar performed well when subjected to these severe winds. The exterior corrugated asbestos siding performed well and experienced only localized failure. There were no failures noted in the heavy “C” channel wall girts or the roof trusses supporting the corrugated siding and the roof decking, respectively. No failures were noted on the main structural elements. The only damage to this building was the removal of a portion of the roofing material and the roof decking, structural damage to two rail mounted hangar door sections, and the removal of exterior corrugated siding along the door pockets. The damage to the hangar is shown in Figures 4.12 through 4.17.

Figure 4.12 Aerial View of Damage to Building 285

The majority of the damage to the roof covering seen in Figure 4.12 is along the edges of the roof line. This damage is consistent with the higher suction pressures that are typically experienced at the leading edges of a structure with a flat roof. One other factor that may have precipitated the damage to the roof membrane is the partial failure of

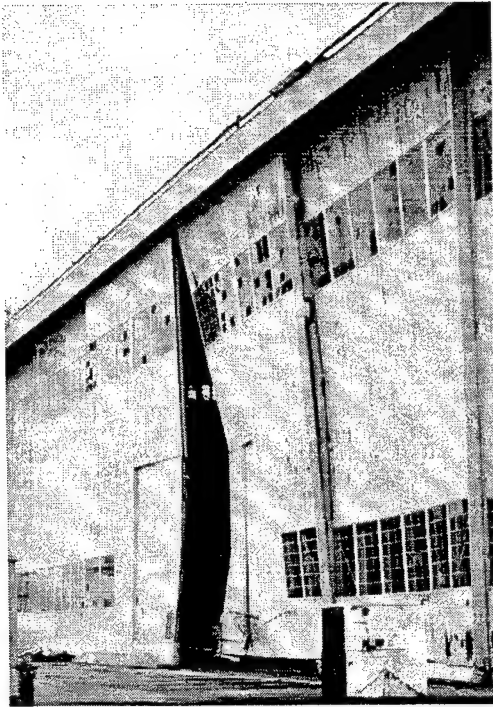
Figure 4.13 Elevation of the North Side of Bldg 285

The partial failure of two sections of the hangar door, as seen in Figures 4.13, 4.14, and 4.15 was caused by wind acting normal to the door surface and weakness in the free edges of the door sections. Because of the secondary openings in the door sections, they did not have a continuous member along their free edge. This lack of a continuous member weakened the structural framing and the lighter secondary framing was unable to transfer the loads into the upper header and the lower rail seen in Figure 4.15. This failure was most likely not due to either a design or a construction deficiency but was simply an area of the structure that had little redundancy.

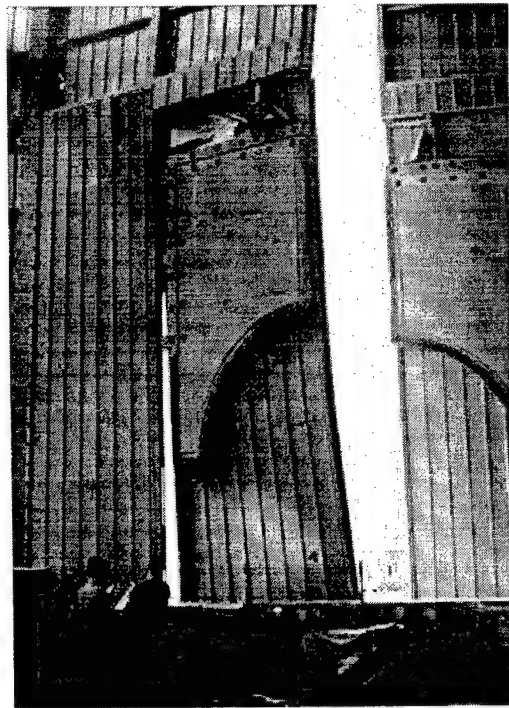
Figure 4.14 Interior Elevation of Damaged Hangar Door

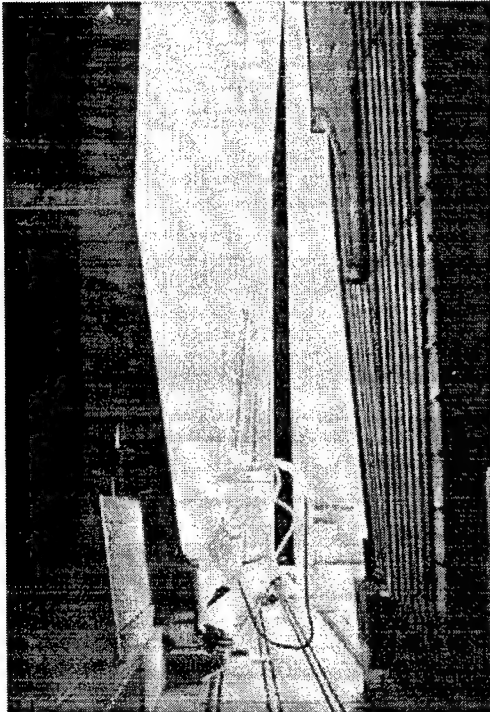
Figure 4.15 Section View of Damaged Hangar Door

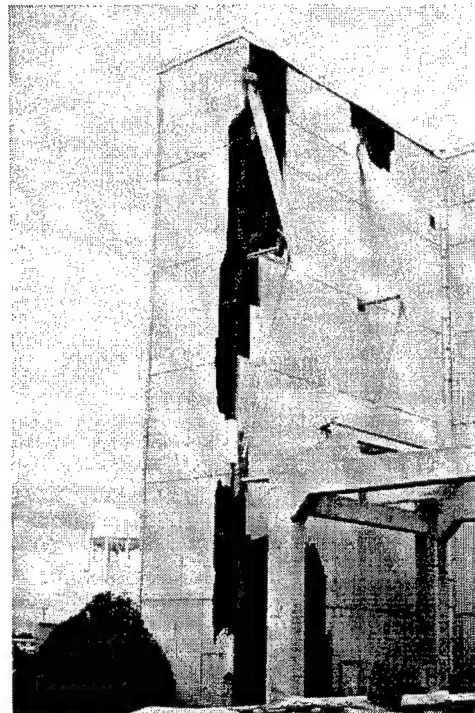
Figure 4.16 Damage to NW Hangar Door Pocket

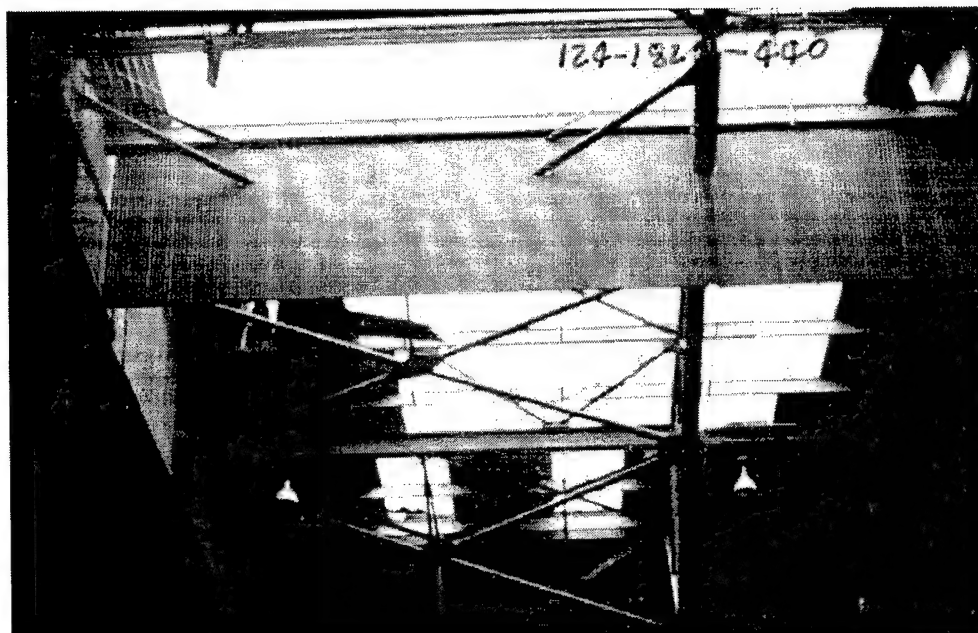
Figure 4.17 Interior of Building 285, NW Corner of Roof

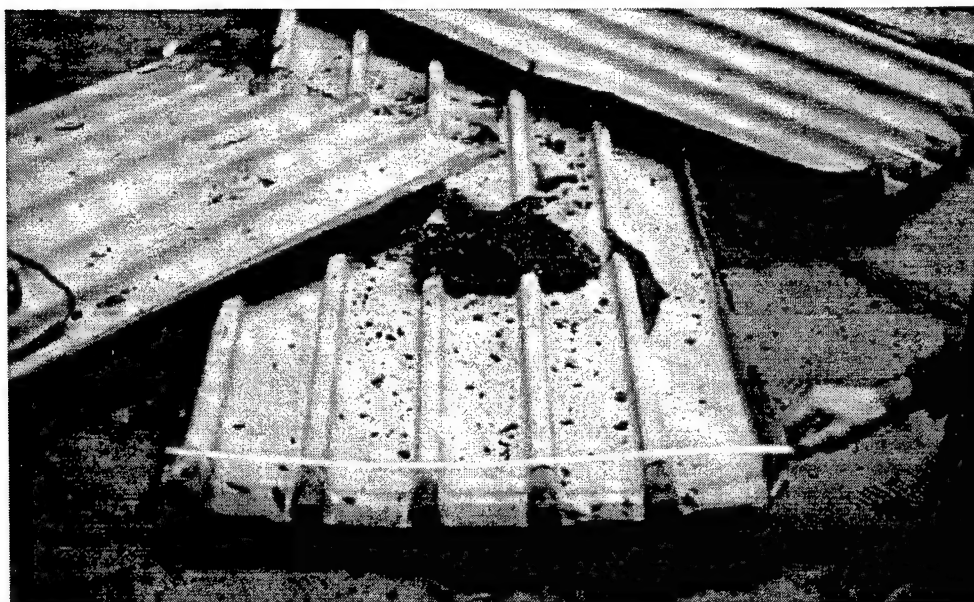
Figure 4.18 Damaged Corrugated Roof Panel, Building 285

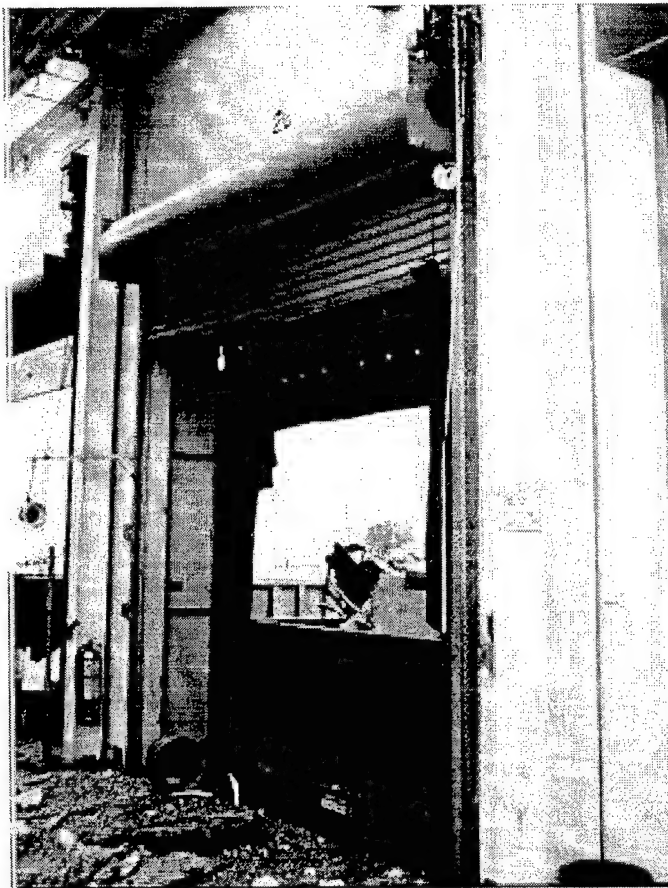
The main structural system performed well and sustained very little damage as did the large overhead doors, shown in Figure 4.19. The only damage to the main structural system was a horizontal crack in the CMU shear wall. The other element damaged was the corrugated steel roof decking. Approximately 80% of the corrugated steel roof deck was torn from the building. The damage mentioned can be seen in 4.20 and 4.21.

Figure 4.19 Undamaged Overhead Door

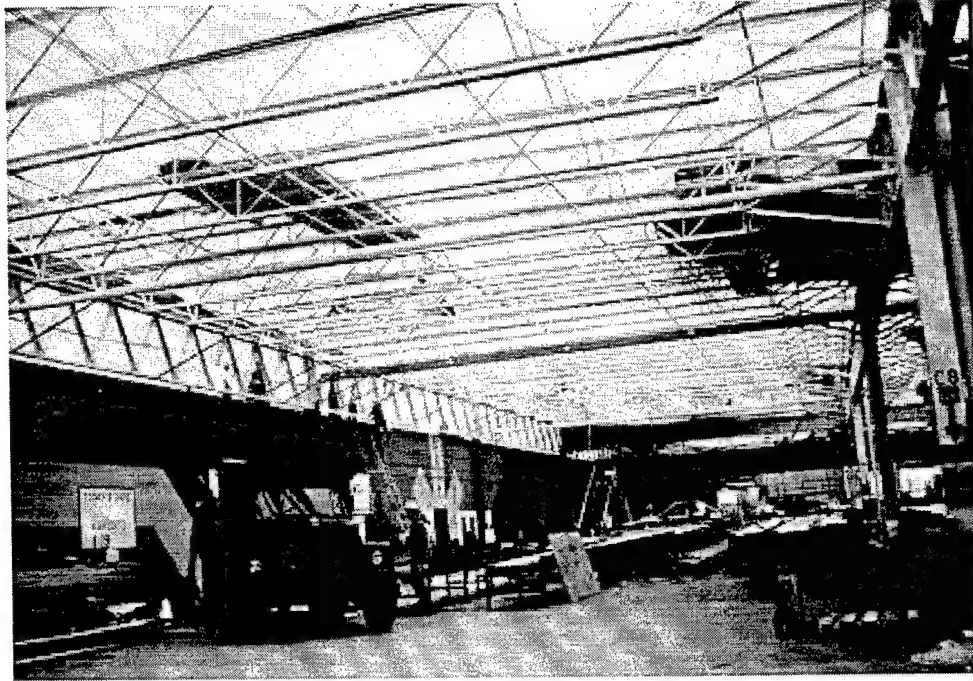
Figure 4.20 Interior of Supply Warehouse

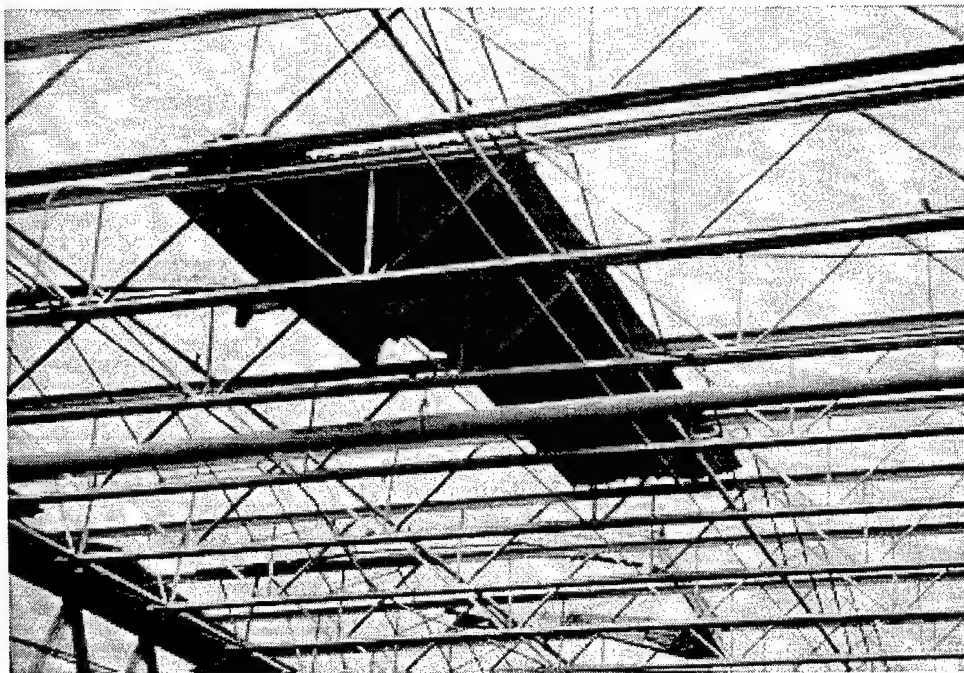
Figure 4.21 Damaged Corrugated Roof Panel

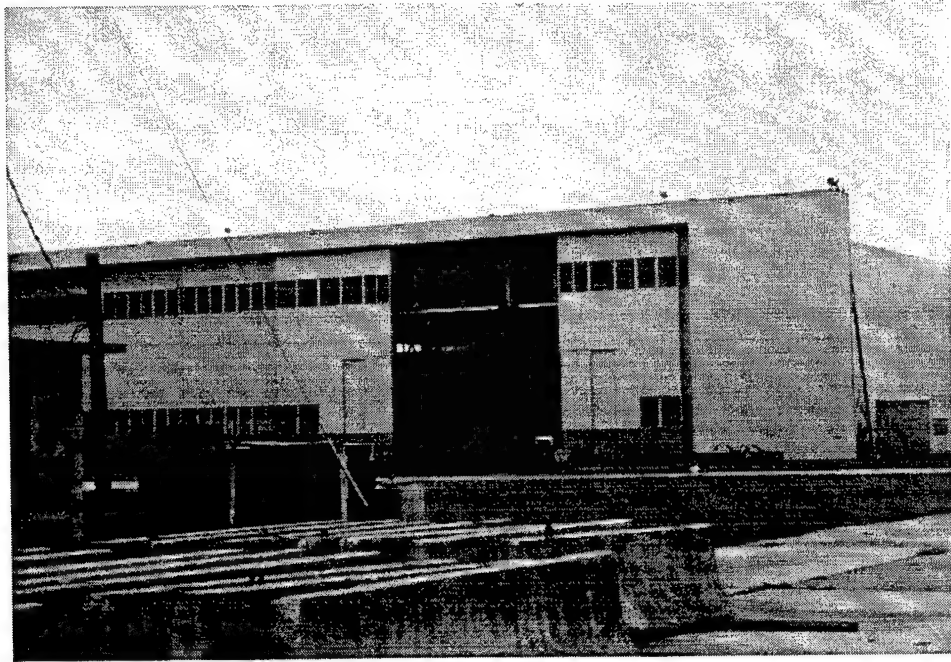
The only visible damage to this hangar is damage to the roof covering and decking. All of the structural members performed as designed, as did the corrugated metal siding. All of the windows in the structure remained intact, as did the hangar doors. These observations of the extent of the damage generally agree with the assessment by McDonald and Smith, 1990. The extent of the damage can be seen in Figures 4.22 and 4.23.

Figure 4.22 Exterior Elevation of Large Hangar

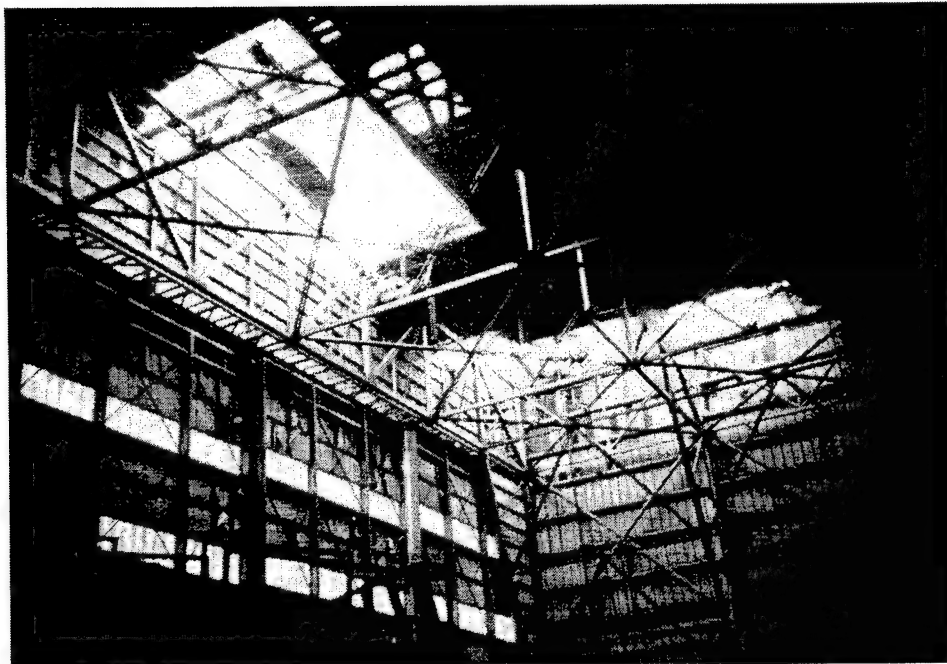
Figure 4.23 Interior Elevation of Large Hangar

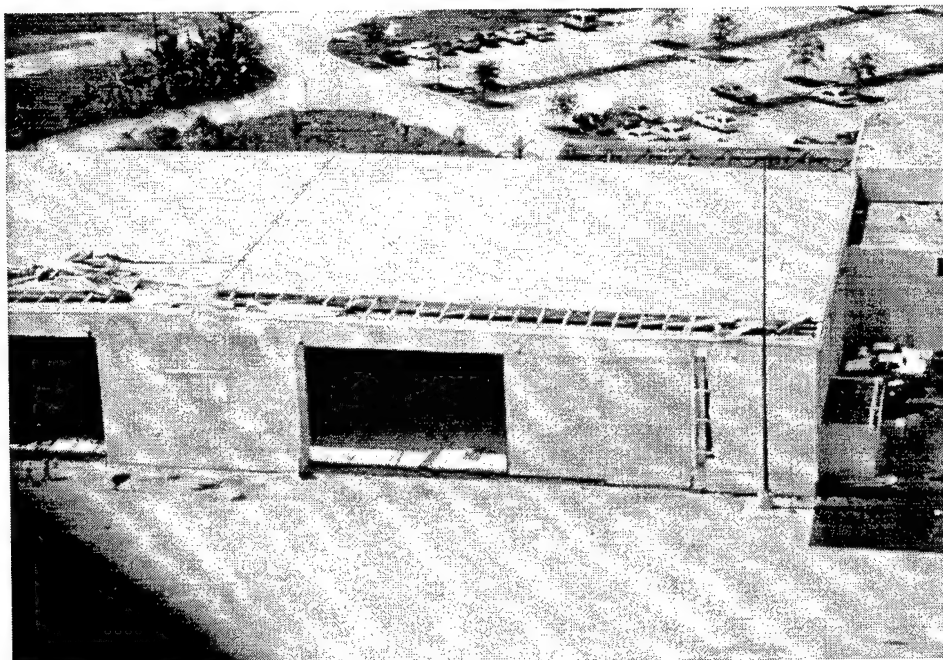
The main component that was damaged on all three hangars was the roof decking. The corrugated siding on the front of the Beechcraft hangar also received minor damage at the door pocket, see Figure 4.25.

Figure 4.25 Elevation of Beechcraft Hangar

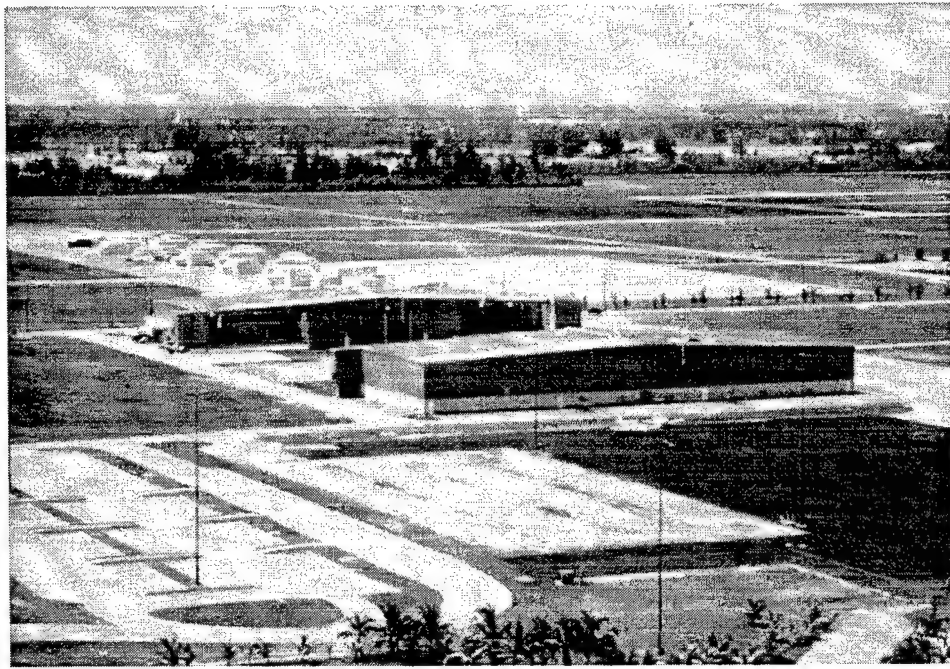
Figure 4.27 Aerial View of Two Damaged Hangars
